Manhole Inspection Summary

Manhole # S59I__020MH

Insp Date: **5/15/08 2:47 PM**

Location Address: **526 oldham**

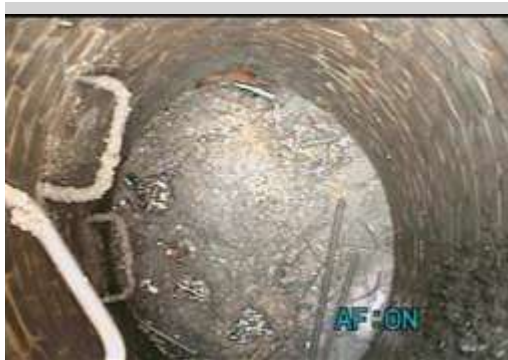
Miscellaneous

debris

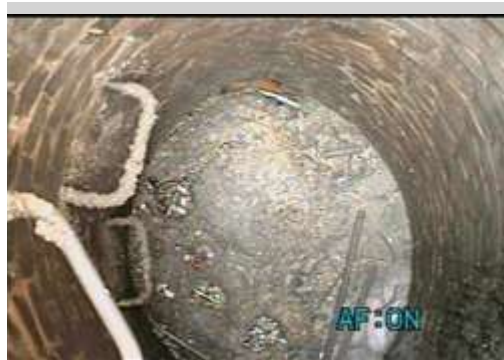
Defect 2

Condition: ☐ Sound ☐ Cracked ☐ Root Intrusion ☒ **Loose Brick** ☒ **Deteriorated**

Infiltration: ☐ None ☐ Joint ☐ Cracks ☐ Mortar ☐ Roots ☒ **Wall**

Steps Count: **3** Missing: **0** ☒ **Corroded**

corroded steps, chimney infiltration (lower right corner)

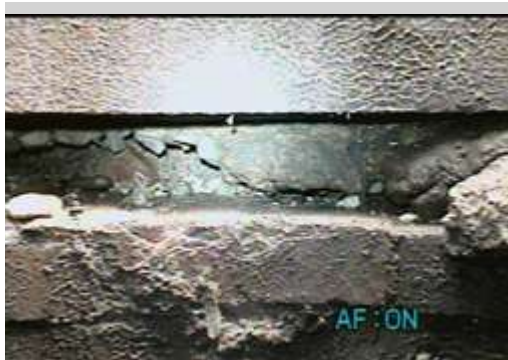
Defect 1

loose bricks, deteriorating chimney
